## **Firmware Release Notes 5.3.1054**

#### **CPI Firmware Release Notes 5.3.1054 (06/2023)**

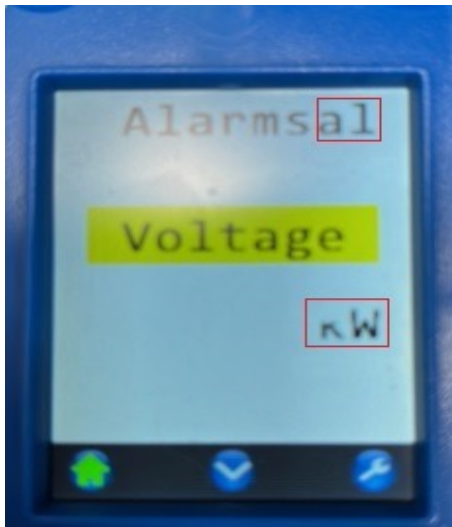
- On rare occasions, text from a previous display may show on the current display – *This is cosmetic only and will be addressed in the next FW Update Release:*
